## Fungi influenced corrosion on nitrocarburized multiphase 4340 steel

### *Corrosão em aço 4340 multifásico nitrocarburado influenciada por fungos*

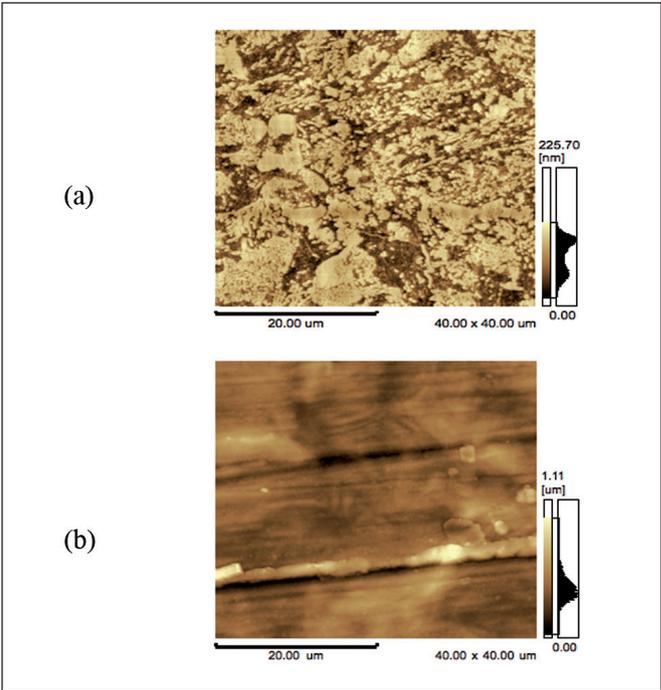
**Figure 2.** Bi-dimensional visualization of atomic force micrographs of (a) untreated and (b) nitrocarburized 4340 steel.

Representative AFM bi-dimensional images with 40 µm x 40 µm of scanning area of the same untreated 4340 steel samples are presented in Fig. 2. In addition

to the microstructures visualization (needle-shaped cementite, dark regions of ferrite matrix and bainite plates, indicated by dashed circles), these images displayed quantitative information about height distribution (right side of each micrograph). In Fig. 2a, the highest peak of the cementite structure is about 225 nm far from the deepest region of the  $\alpha$ -ferrite matrix. In Fig. 2b, the value 1.11  $\mu\text{m}$  is the distance between the scratch bottom and the highest peak hill on the scratch edge.

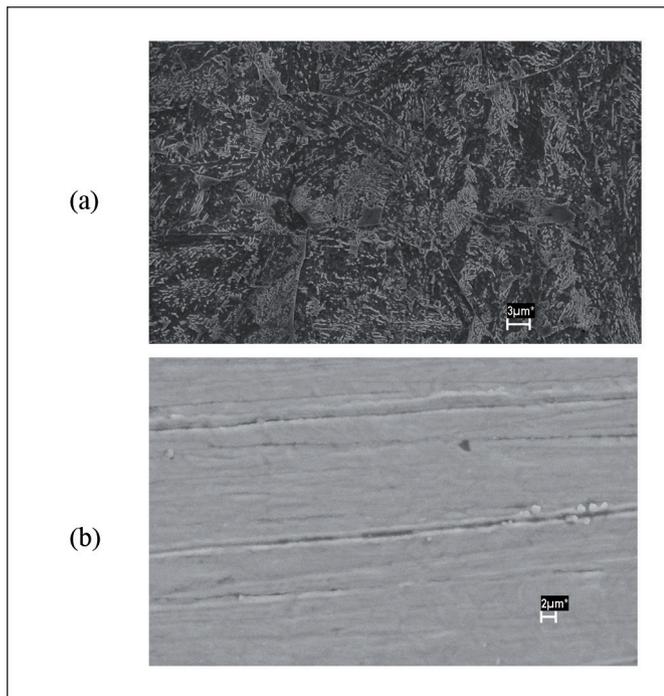
**Figure 1.** Scanning electron micrographs of (a) untreated and (b) nitrocarburized 4340 steel.

Figure 1a shows a characteristic image of the untreated 4340 steel surface obtained by SEM. Typical cementite microstructures (needle-shaped Fe<sub>3</sub>C) can be seen over the ferrite matrix (α-Fe, dark regions). Some bainite plates can also be visualized (dashed white circles). It is important to notice that after the plasma nitrocarburizing, these microstructures could no longer be identified (Fig. 1b).

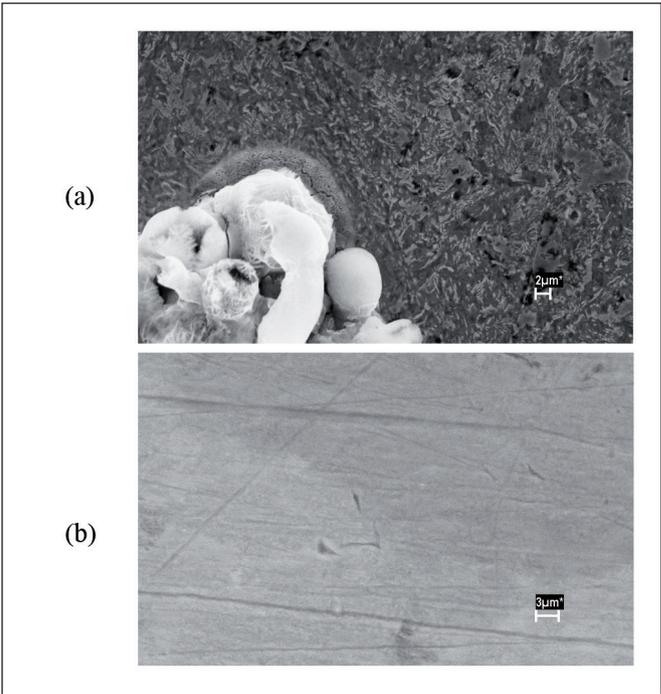
**Figure 3.** Scanning electron micrographs of (a) untreated (indicating biological corrosion) and (b) nitrocarburized 4340 steel.

Biocorrosion produced morphological alterations in the untreated steel, easily identified by SEM. It can be observed in Fig. 3a, some pits (cavities on the surface, indicated by the smaller arrows) and also new structures (clear region, indicated by the larger arrow). The EDS microanalysis on these new structures revealed high contents of oxygen (32% in weight), which has not been detected in the metal before biocorrosion. This result strongly suggests that oxide formation originated these new morphological structures.

As can be seen in Fig. 3b, the surface of a nitrocarburized 4340 steel after the biocorrosion process showed no significant morphological alterations due to biocorrosion. In addition, the EDS microanalysis on the nitrocarburized 4340 steel has detected only 7% of oxygen content after biocorrosion. These results supported the finding that nitrocarburizing treatment of the metal is also an effective protection against biocorrosion.

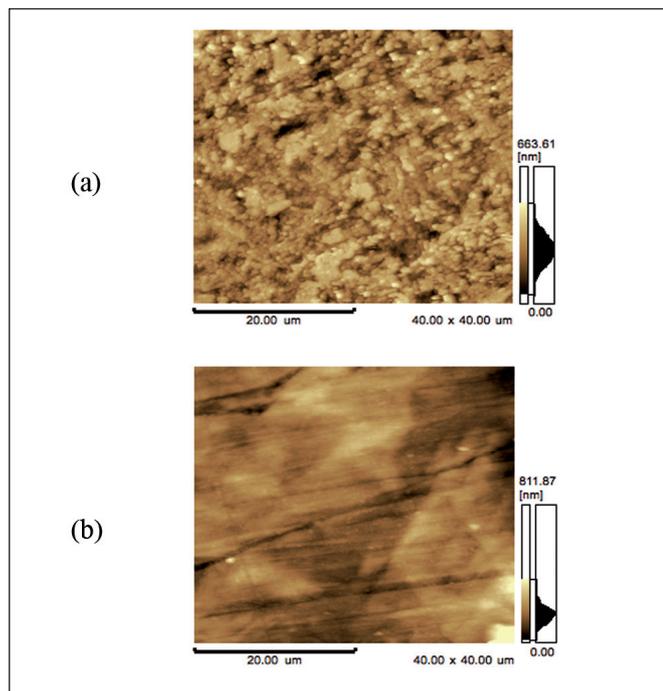
**Figure 4.** bi-dimensional visualization of atomic force micrographs of untreated (a) and treated (b) 4340 steel after biocorrosion.

Figure 4 shows AFM images of untreated and treated steels after biocorrosion. In Fig. 4a, in addition to some pits of corrosion (white arrows), it can be seen that all the structures have lost their original morphology. Topography

also changed drastically, increasing the height distribution scale to 663 nm. On the other hand, Fig. 4b corroborates Fig. 3b: no appreciable changes in morphology and topography of the nitrocarburized steel surface were measured by AFM after biocorrosion.
