## LEAK TESTING THE CBERS-FM2 SATELLITE PROPULSION SYSTEM

Keywords: Helium Leak Tests, Space Simulation, CBERS satellite

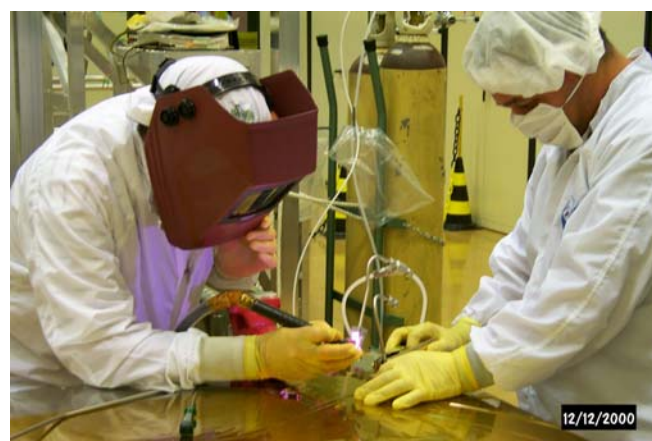
Figure 1 - Titanium pipeline welding process

In order to control and maintain the satellite proper attitude while in orbit, a critical condition for the correct appointment to the ground of the three cameras and the solar panel to the sun, a subsystem composed mainly by four 28-liter fuel tanks, 18 firing thrusters, 12 valves, some filters and the dedicated pipeline is included in the satellite Service Module. Most of these components are made of titanium and stainless steel. In order to feed the thrusters installed at their proper operational locations, the dia. 6mm x 1mm thickness titanium pipeline had to be curved and bent in angles to follow the routing through the spacecraft internal geometry. Inter-connections and valves are also required for the firing procedures. Some pictures of part of the CBERS FM2 propulsion system are shown in Figures 1, 2 and 3.

The tubing of the CBERS satellite propulsion system was made of titanium, most of it in 6mm external diameter. Because of the diverse internal geometry of the spacecraft, this pipeline had to be built in several sections that were subsequently welded to obtain the 3-D configuration of the internal routing in the spacecraft. Although this welding process was performed in a specially built and dedicated laboratory with cleanliness of Class 10.000, leaks and other non-conformities could arise during the integration and inter-connection procedures, and also from the vibration caused by the transport and acoustic test activities.

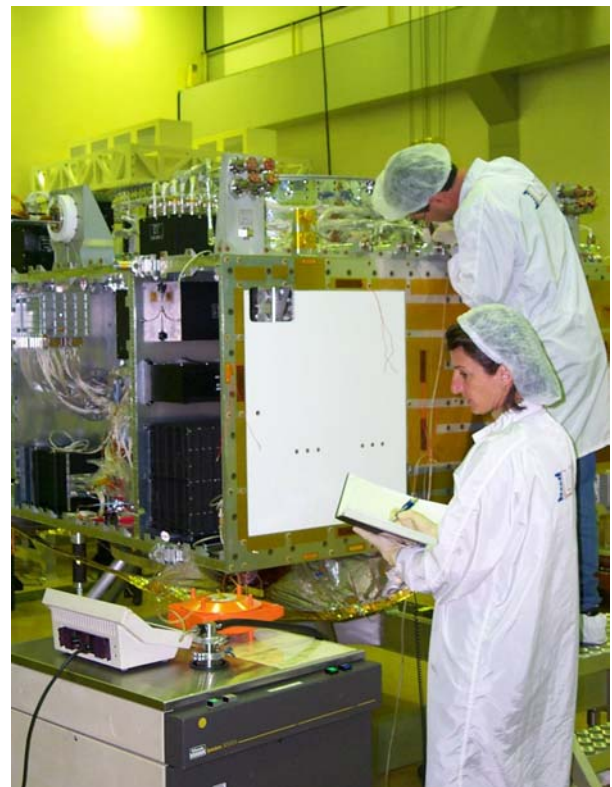
Figure 4 - Local Leak Tests - INPE

To perform the *Local Leak Tests* the spacecraft Service Module was located in a clean room area of the laboratory in Brazil and then its propulsion system, after being evacuated, was pressurized with 99.999% grade Helium to 2.0-2.2 MPa in order to reproduce the flight pressure (1.7 MPa) plus a safety margin of 0.5MPa. In the sequence, after the calibration procedures of the Leak Detector, each significant individual spot of the propulsion system, one by one, was properly checked by the Leak Detector sniffer. Of great concern were the valves, pipeline connections and actuators. In order to get the most of any possible leak, small plastic bags were placed around each one of the selected spot to be leak tested. These were done to ensure a separate atmosphere from the external environment. At the end of the sniffer probe, a sharp needle could then cut a small hole in the plastic and, for at least 10 seconds, to check for the leak tightness of that particular spot. A picture showing this operation can be seen in Figure 4.

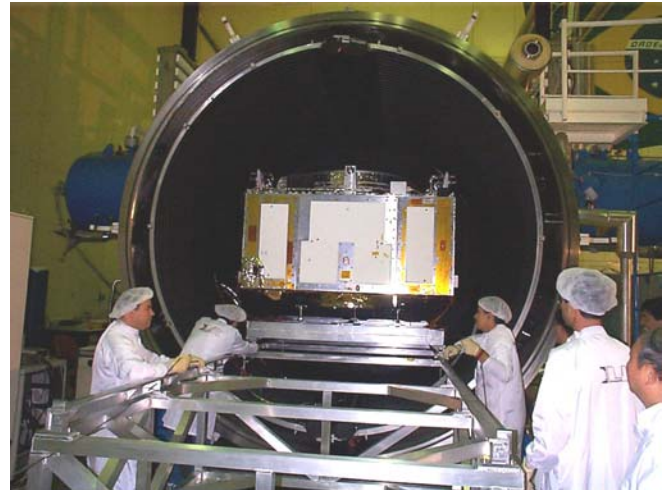
**Figure 5 - Preparation for *Global Leak Tests* – INPE.**

In the sequence, it was performed the *Global Leak Tests* of the CBERS FM2 spacecraft. For this, it was also required its propulsion system to be pressurized with 99.999% high grade Helium to 2MPa. Following the planned sequence, the whole Service Module was installed in LIT 3m dia. x 3m long Space Simulation Chamber. This chamber was built using 304L Stainless Steel and, to get its high vacuum conditioning, it is equipped with two 35" 25,000 l/s (blue painted) cryopumps. A picture of this test set up is presented in Figure 5. At one of the vacuum ports of this thermal vacuum chamber the Helium Leak Detector was connected, valve closed (see Figure 6).

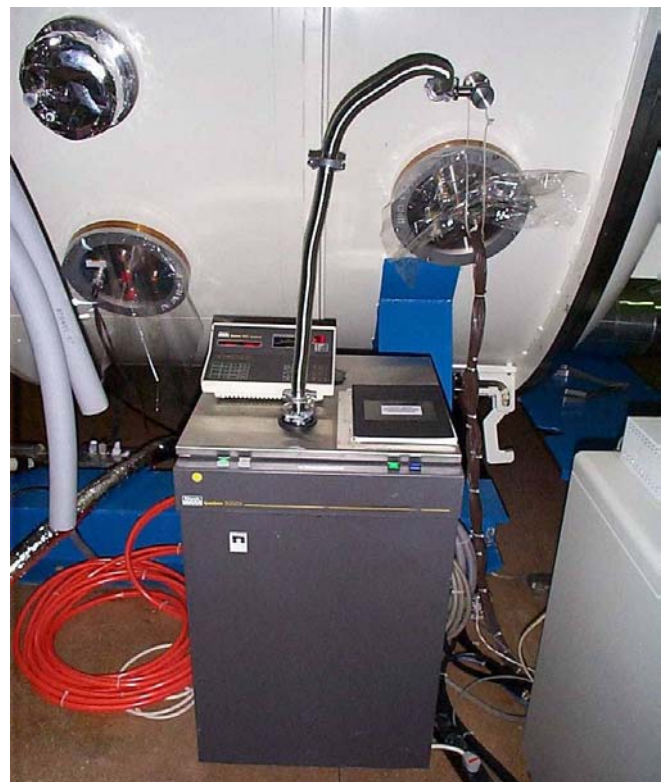
**Figure 6 - Leak Detector connected to TVC port.**

The Leak Detector to Thermal Vacuum Chamber connection port valve was carefully opened and the rate of leak coming from the entire pressurized spacecraft propulsion

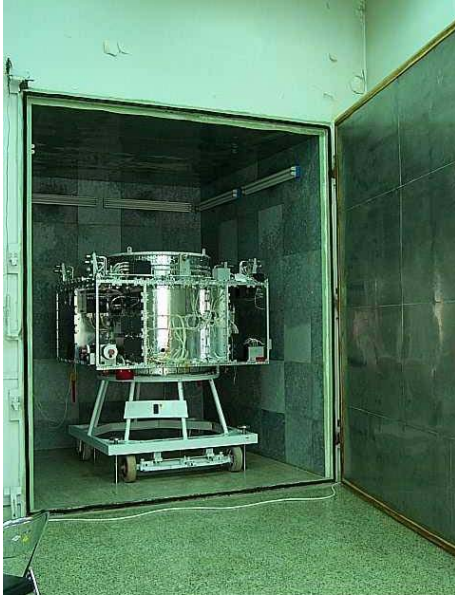
**Figure 7 - CBERS FM2 in Atmospheric Chamber for the Global Leak Tests procedures – China.**

The chamber used as the hood had a volume several times larger than the CBERS Service Module. The SM propulsion system was again pressurized with He at 2MPa. In order to analyze the He concentration (partial pressure) inside the Chamber, three sequential steps were performed. The first one was executed in order to get a reading at the time the spacecraft was just installed inside the Chamber and the door closed. The second one followed the same test set-up, but performed at 24 hours later. The third step required an injection of a precise volume of virtually pure Helium (99.999%) at a pre-defined pressure. The results from this sequence were then used to calculate the variation of He concentration inside the Chamber and consequently the global He leakage from the Service Module [4].

That Chinese rectangular shaped Chamber had metallic door and granite walls. The hinged door was sealed to the Chamber frame by using rubber and foam compression strips. A blower, installed on the left wall of the Chamber, was used to increase the uniformity of the gaseous environment prior to each sample reading. Rubber hoses protruding into the Chamber, also from the left wall and located approx. 1m from the floor were used to collect and replace the sample to perform the concentration analysis. A Mass Spectrometer, coupled to a HP 34401A Multimeter to get the output readings, was used to measure the mass 4 concentration of the Helium gas. A large control panel, containing valves and analog pressure and flow gauges was used to set and to control the parameters of the flow to the Chamber. A two-way selecting valve was used to alternate from a standard He sample (99.999%) to the flow coming from the Chamber. A small pump was used to produce the gas flow in a close circuit from the Chamber through the Mass Spectrometer analyzer.

A picture showing the CBERS FM2 spacecraft installed inside the Chinese atmospheric pressure chamber can be seen in Figure 7.

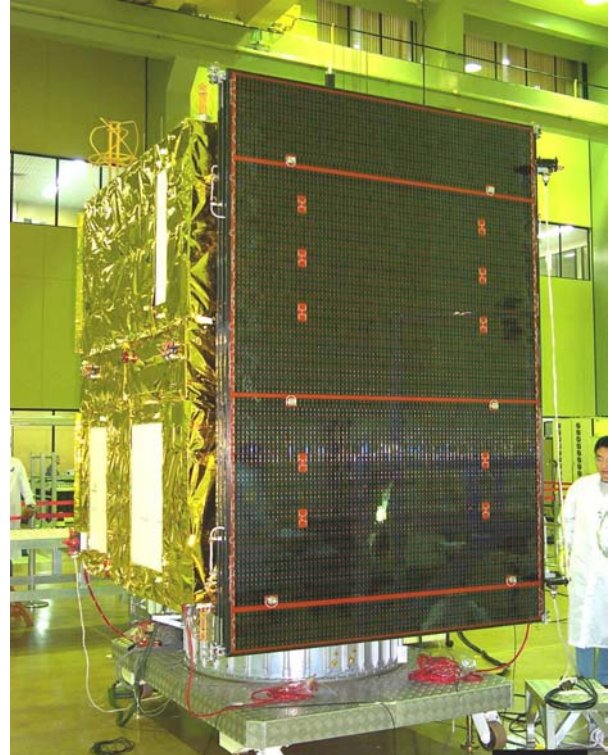
**Figure 8 - CBERS FM2 satellite**

A picture of the CBERS FM2 satellite with its folded solar array is shown in Figure 8. This satellite is now orbiting the Earth, producing clear images from China and Brazil.
